Manhole Inspection Summary

Manhole # S23GG_007MH

Insp Date: **10/2/07 9:48 AM**

Location Address: **1524 BAKER ST**

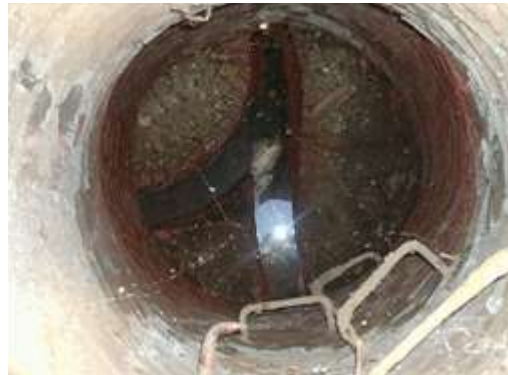
Top View

Corroded and missing steps. Evidence of surcharge - Bench debris. Channel debris.

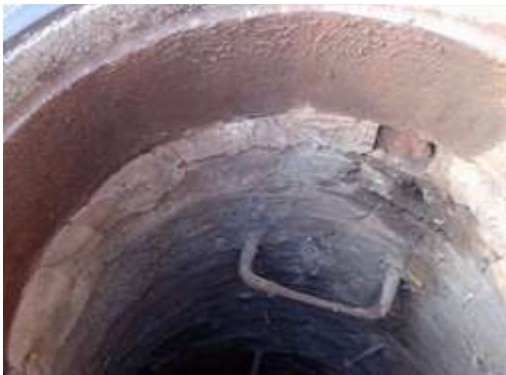
Defect

Frame leaks. Adjustment deterioration and infiltration. Barrel infiltration - other side.

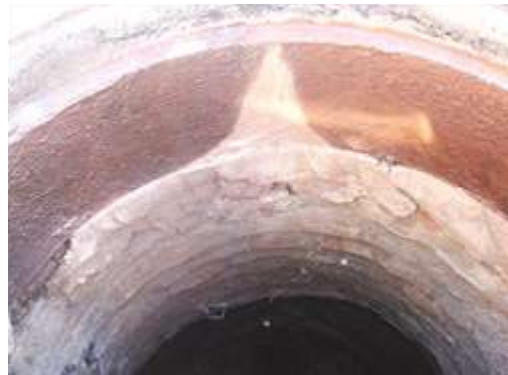
Defect

Frame leaks. Adjustment deterioration and infiltration. Barrel infiltration.

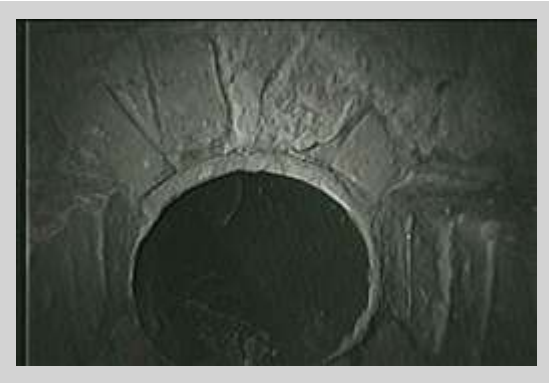
8 in. Circular Gravity Sewer Pipe Out @ 12 O'Clock

Deposits: ☐ None ☐ Mud ☒ **Sludge** ☐ Debris ☐ **Grease**

Infiltration: **None** Pipe Seal Cond: **Cracked**

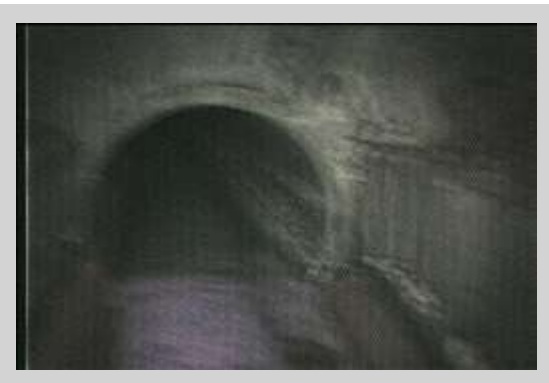
8 in. Circular Gravity Sewer Pipe In @ 6 O'Clock

Deposits: ☐ None ☒ **Mud** ☐ Sludge ☐ Debris ☒ **Grease**

Silt Depth: **0.5** (in.) Deposits Extent: **Light**

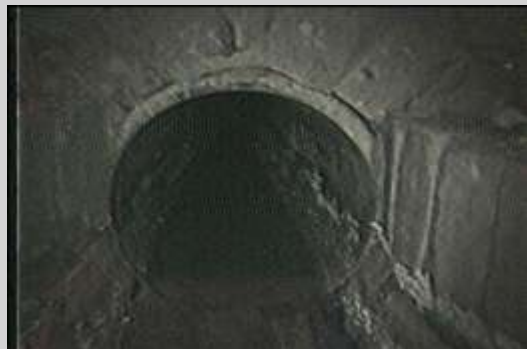
Pipe In @ 9 O'Clock

Channel deterioration.

Deposits: ☐ None ☐ Mud ☐ Sludge ☐ Debris ☒ **Grease**

Infiltration: **Evidence**

Pipe Seal Cond: **Cracked**
